## Data XRF analysis (Röntgenfluorescentiespectrometrisch onderzoek)

| Object | V259 (KN&V) white string on rim | |
| Artist | Ettore Sottsass (execution Toso Vetri d'Arte) | |
| Title and date | Sol - glass, freeblown, applique | 1982 |

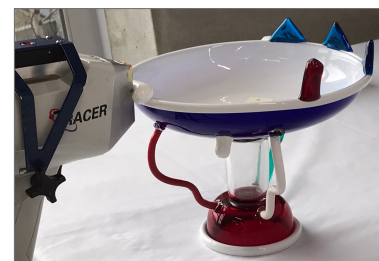
### Location mapping of compositional analysis and measurement of approximate glass thickness

| Practical limitations | Perhaps the curvature of the strand might have affected the measurements |
| App. thickness in mm. | <b>16,70</b> (at location of measurement - point 4 - white string on rim) |
